# Railroad accident investigation report

Report No. 79-9

LOUISVILLE AND NASHVILLE RAILROAD COMPANY

CRESTVIEW, FLORIDA

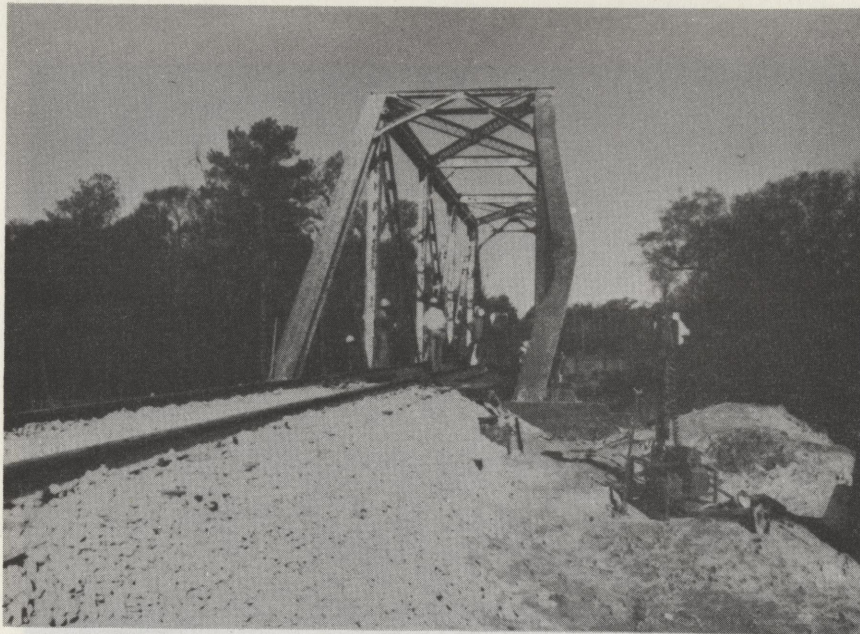
Post-accident examination of the bridge structure revealed that the 72-foot, pile-driven trestle was completely destroyed by the derailment and resulting fire. The thru-truss span sustained substantial damage to the southeast hip hanger, south end stringers of panel five, east bottom chord of panel five and south end floor beam. Heat damage was also sustained to various other bridge members. The 125-foot track structure on the thru-truss span of the bridge received extensive heat damage from the burning cars. About 80 percent of the ties and 70 percent of the rail were destroyed on the truss. Samples of the web of the south ends of both stringers, the bottom flange angles, and a rivet from the west stringer were tested by an independent laboratory. The results indicate that the fire did not alter the metallurgical or mechanical properties of the samples tested.

Damage to west portal member of Yellow River bridge.

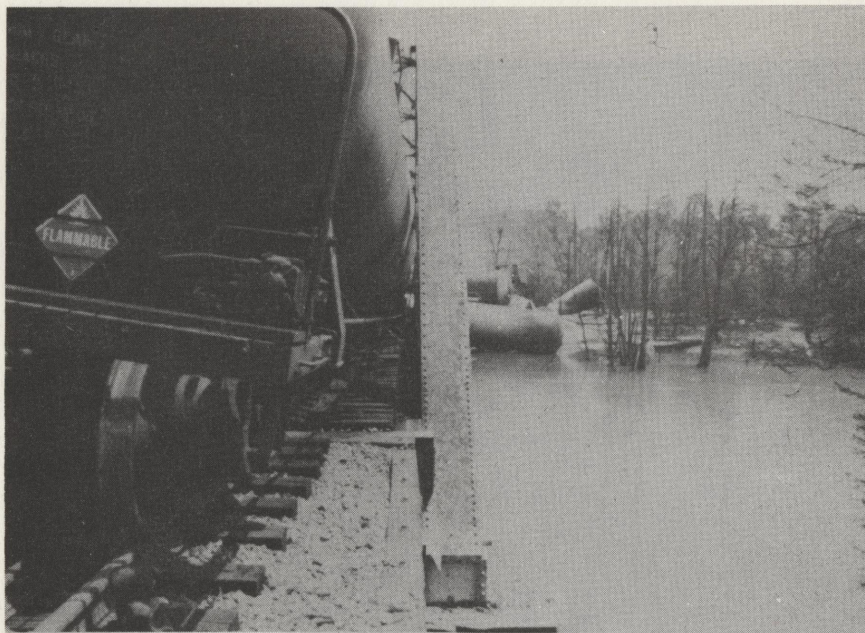
View of derailment site from east portal member of bridge

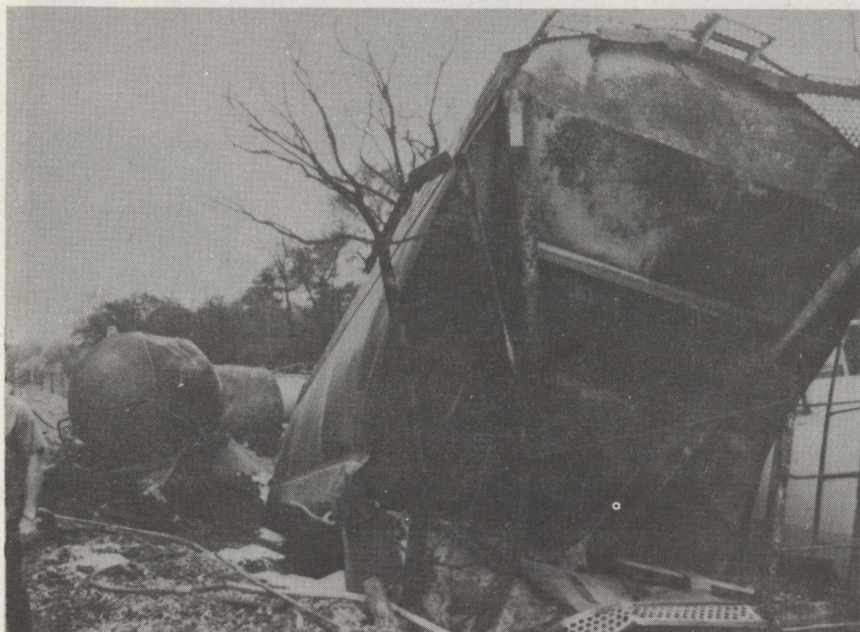
View of damaged equipment.

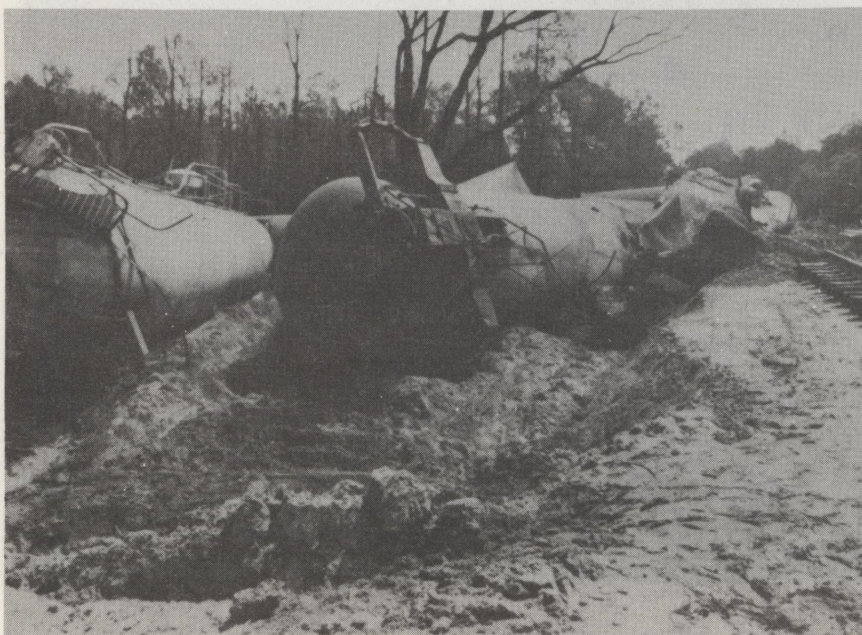
View of damaged tank cars.

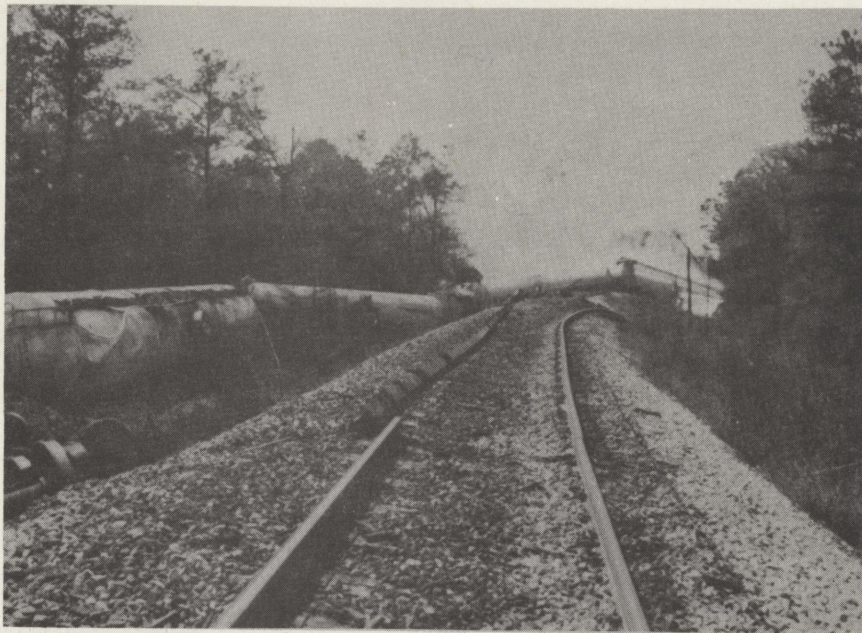
The carrier recovered all except 25 feet of the west rail from the accident area. All rail recovered from the wreck site was examined. This examination revealed only stress breaks and no signs of internal defects. Marks on the rail did not indicate where the initial derailment had occurred. Although 25 feet of the west rail, which was the low or stress rail in the accident area, was never recovered, examination of the cars which passed the derailment site did not reveal any of the markings which are usually associated with the presence of a broken rail.

**Track structure after derailment.**

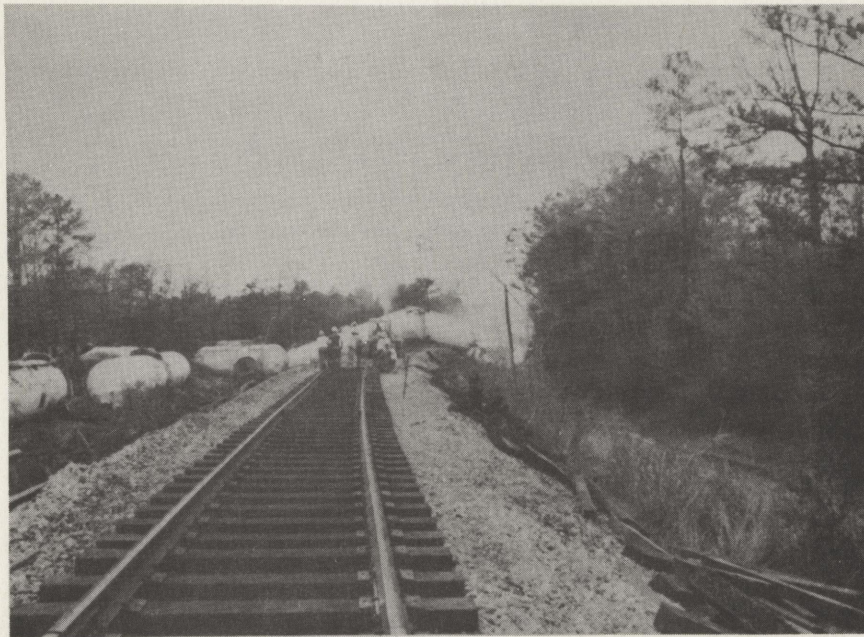
**Track structure being restored.**

The wreck was cleared, the track and bridge were temporarily repaired, and train operations were resumed on April 14, 1979. At that time, L&N issued additional operating instructions on the line between Pensacola and Chattahoochee, Florida. Southward trains were restricted to a maximum of 120 cars and 8,000 tons. A speed restriction of 5 mph, later increased to 10 mph, was placed in effect in the area of the derailment until permanent bridge repairs could be made. Supervisors were assigned to ride all road trains on this sub-division for a period after the track was reopened.
